# Sterile Product Package Integrity Testing

## Current Practice, Common Mistakes, New Developments

By Dana Morton Guazzo, PhD

May 17, 2010

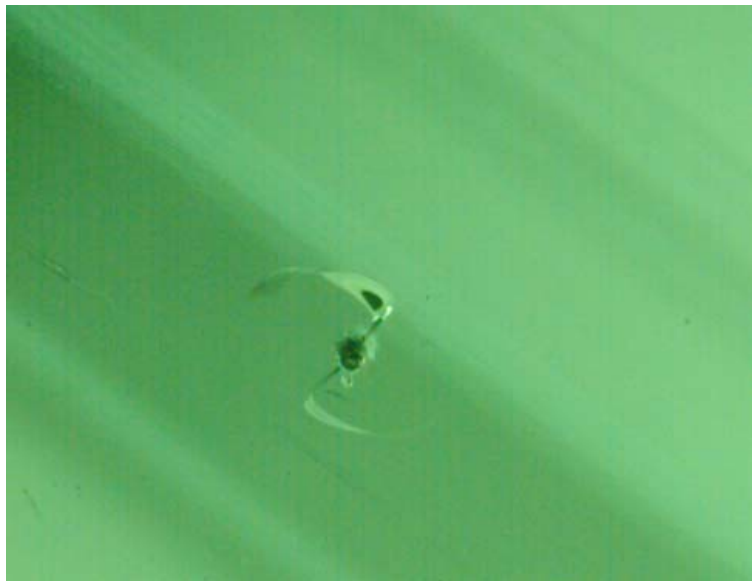
## Glass Syringe Defects by Lenox Laser Nominal hole size 5 $\mu\text{m}$

Microscope photo by BMS

Electron-microscope photo by Amgen

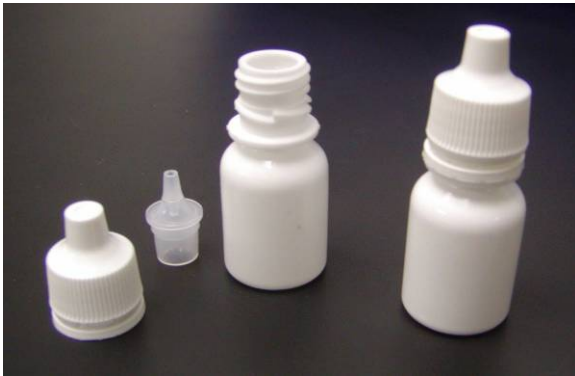
# Positive Control Type Defect Example

**Hole creation**  
0.10 – 0.16 mm

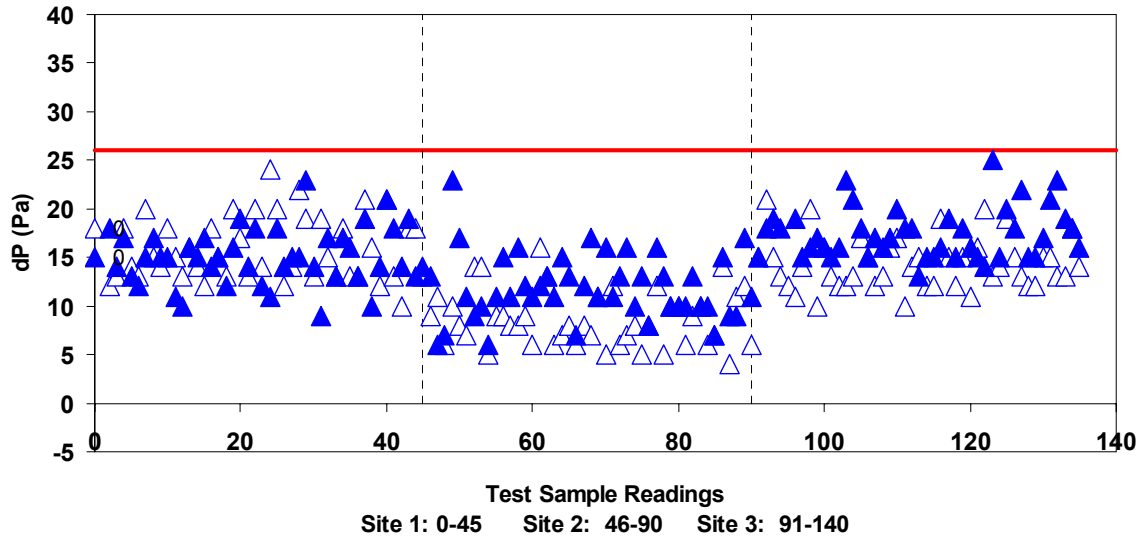
## Vacuum decay Negative control syringes

- △ Study 4, Water-filled Syringes for Gas Leak Tests
- ▲ Study 5, Water-filled Syringes for Liquid Leak Tests
- dP Ref Pass/Fail Limit

Study	No. Packages Tested	No. Tests	No. FAILED	No. PASSED	% Accurate
<b>Study 4: Water</b>	<b>15</b>	<b>135</b>	<b>0</b>	<b>135</b>	<b>100</b>
<b>Study 5: Water</b>	<b>15</b>	<b>134</b>	<b>0</b>	<b>134</b>	<b>100</b>

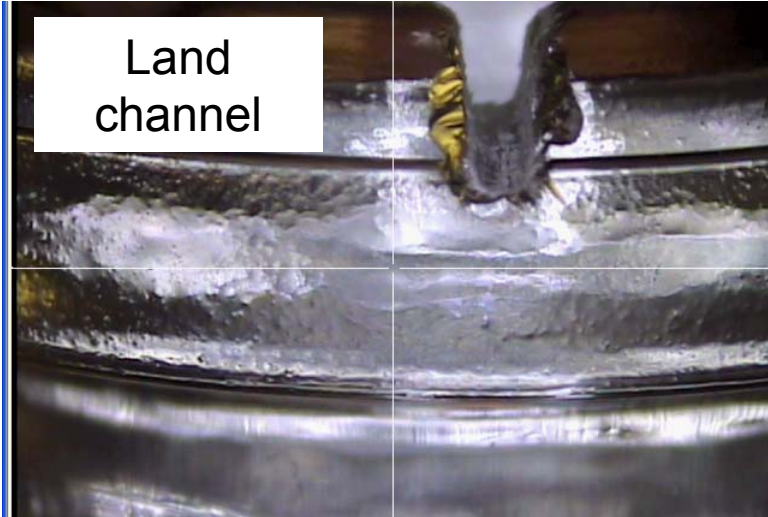
135X, Magellan V20 Video Microscope

- Artificial defects created for leak testing
  - Holes through vial neck - Laser drilled
    - Lenox Laser, Glen Arm, MD
    - Sizes 15, 25, 50  $\mu\text{m}$  nominal diameter
  - Channel defect – Dremel<sup>®</sup> saw
    - Land surface (horizontal, top)
    - Valve surface (vertical, neck)
    - Land + valve surfaces
    - Sizes 0.7-3.1 mm (W) x 0.6-1.5 mm (H)
- No defect – Negative controls

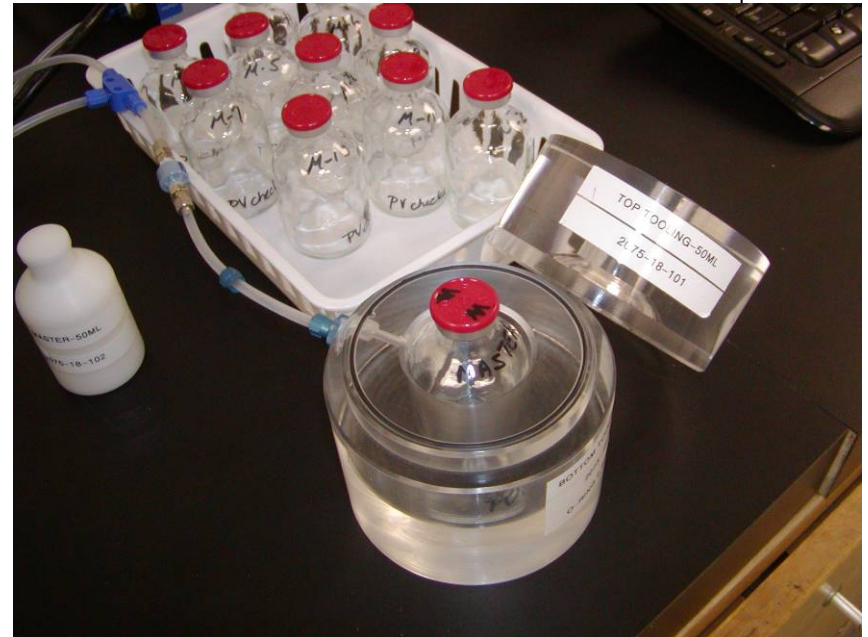
PTI VeriPac 325/LV

## ASTM F2338-09

Test chamber

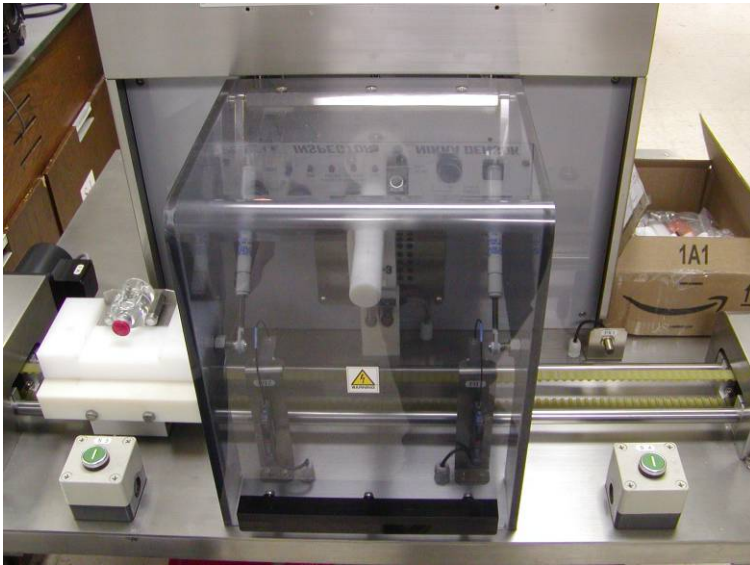
Nikka Densok HVLD Model HDT1

Positive leak detection

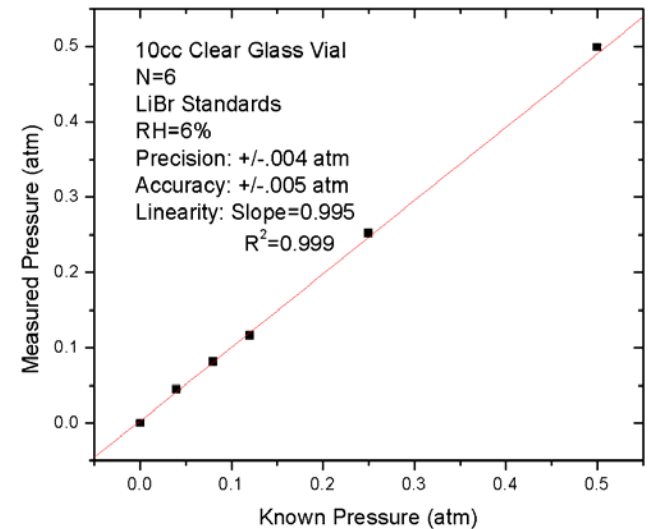
## Pressure vs. Peak Width

## Linearity validation

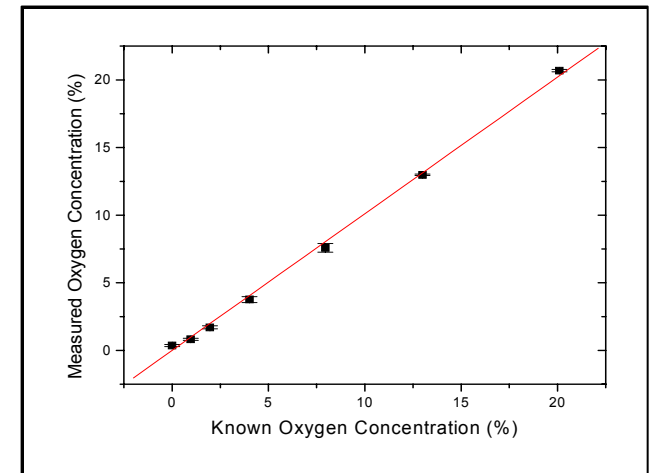
## O<sub>2</sub> Concentration vs. Signal Amplitude

### Linearity validation
