High Voltage Leak Detection (MicroCurrent). HVLD^{MC}

- Case Study: HVLD with Albumin Solution
- Case Study: HVLD Vs. Vacuum Decay with Albumin Solution

Tatiana Simental
CCIT General Manager
PDA, Copenhagen 2024

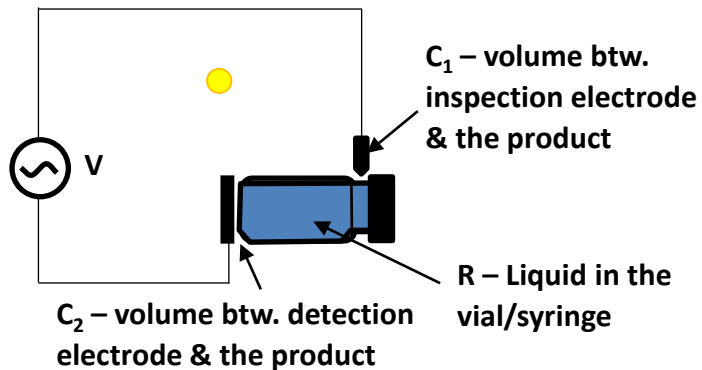
Functional Principle of HVLD^{mc} Test

Good Sample

2 capacitors

Leak

1 capacitor

V – High Voltage Source

R – Electric Resistance of the product

C₁ – Capacitor 1: Glass between the inspection electrode and product

C₂ – Capacitor 2: Glass between the detection electrode and product

I₁ – current produced when product container is sealed

I₂ – current produced when product container is defective

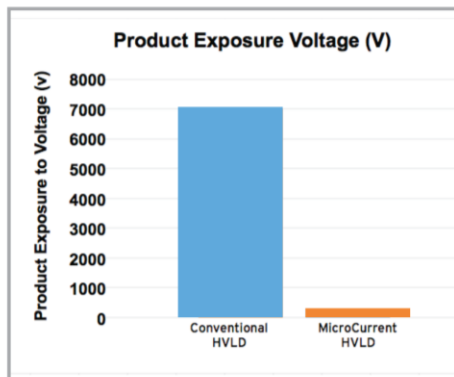
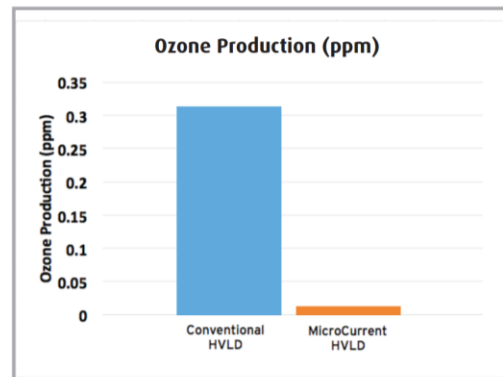
Ozone Creation

10 minutes test
Outside the product

Conventional HVLD	MicroCurrent HVLD
Exposure Voltage (V)	7000	300
Ozone Production (ppm)	0.305	0.006

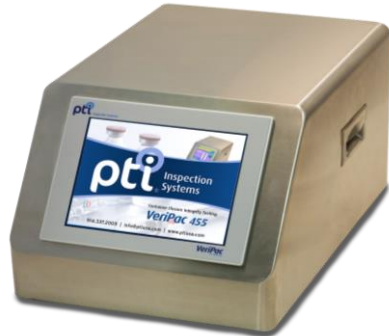
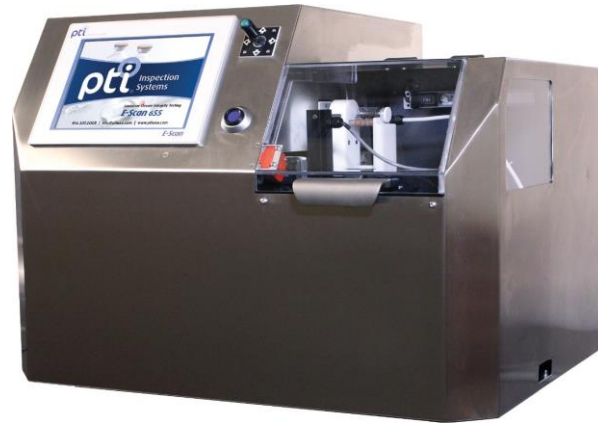
Case Study 1: HVLD with Albumin Solution (1,2,3 and 66 days)

- ✓ 2R (4ml capacity) glass vials
- ✓ 13mm Teflon faced stopper, Flip Off Seal 13 mm
- ✓ Positive Controls: 5, 10 und 15 μm laser drilled holes, neck and bottom
- ✓ 3 positive control samples of each hole size and position
- ✓ 4 rounds of testing; 3 consecutive days, and one round 66 days later in different locations (NY-CH).
- ✓ Fill volume was 3ml 20% Albumin solution for both PC and NC groups. Vials were filled prior to testing, stoppered and crimped.

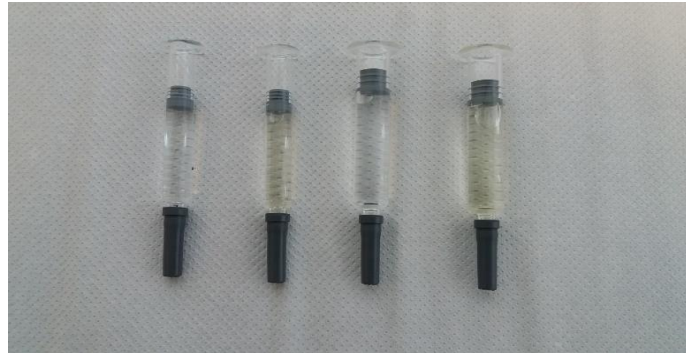
Case Study 2: Vacuum vs. HVLD^{mc} for PFS

- ✓ 1mL and 2.25 mL Syringe (Water and Albumin)
- ✓ Positive Controls: 5, 10 und 20 µm laser drilled holes, barrel and shoulder.
- ✓ 3 positive controls with water for each size
- ✓ 5 positive controls with Albumin for each size
- ✓ Albumin concentration of 17.5%
- ✓ Two test methods: Vacuum Decay and HVLD^{mc}

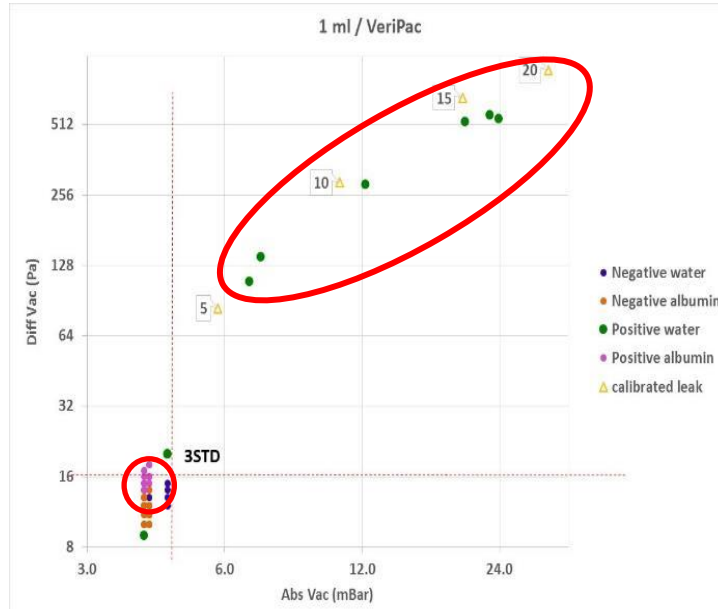
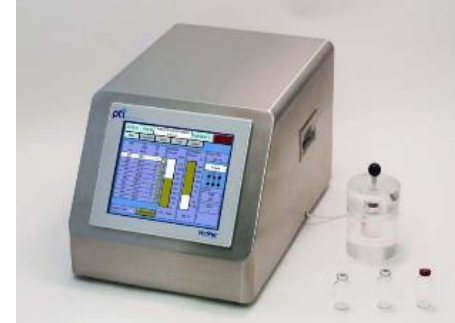
- Vacuum Decay @ <5.0mbar
- Albumin & Water Samples
- Laser Drilled Defects 5, 10, and 20 μ m.

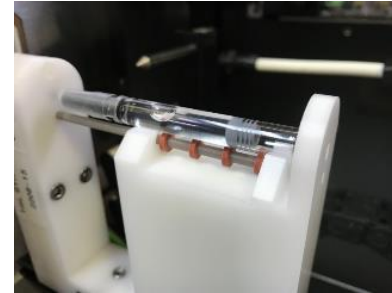
HVLD^{mc}

HVLD shows a clear advantage in detecting defects in parenteral packaging containing large molecule products.

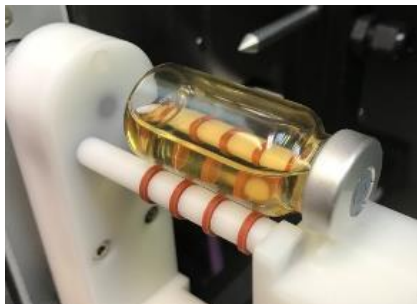
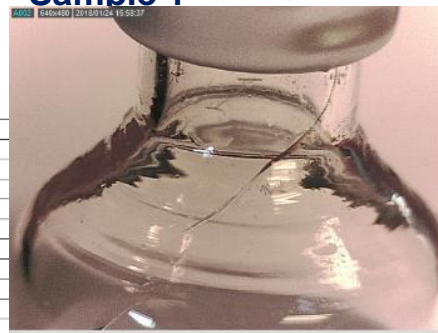
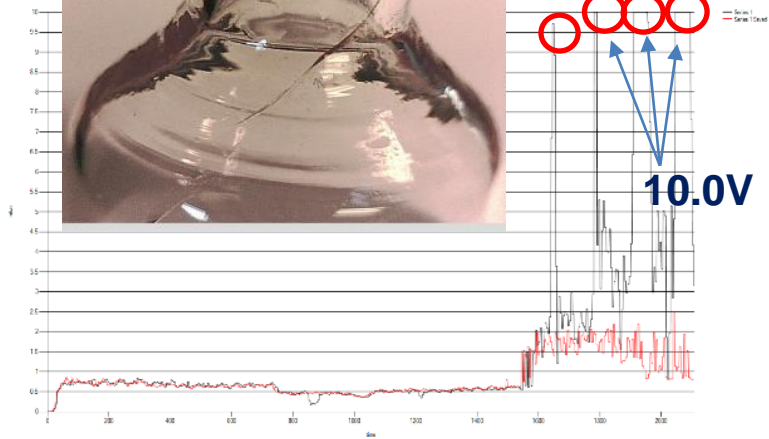
Sample 1

- ❖ Controlled crack produced.
- ❖ Certified flow measurement with Helium mass spec.
- ❖ Peak signal response is recorded.
- ❖ Voltage signal response with each rotation.

He Certified Leak Rate	
95.0	10 ⁻⁵ mbar·l/s
0.05700	sccm
2.67	~µm

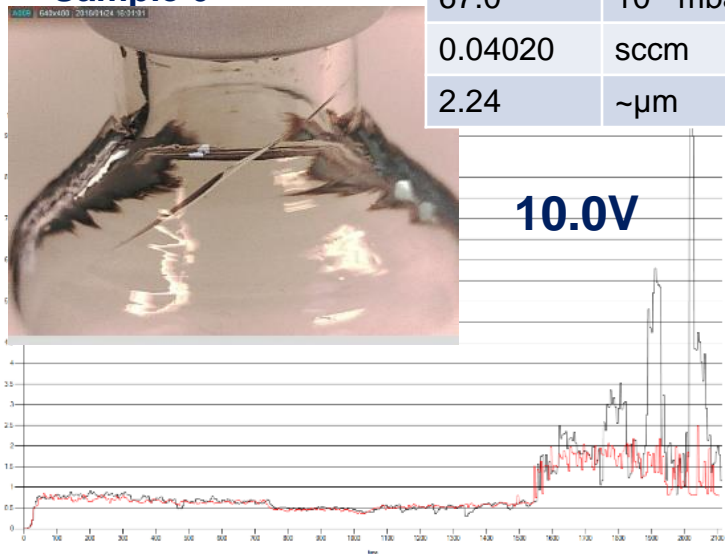
Sample 6

He Certified Leak Rate	
67.0	10^{-5} mbar·l/s
0.04020	sccm
2.24	$\sim\mu\text{m}$

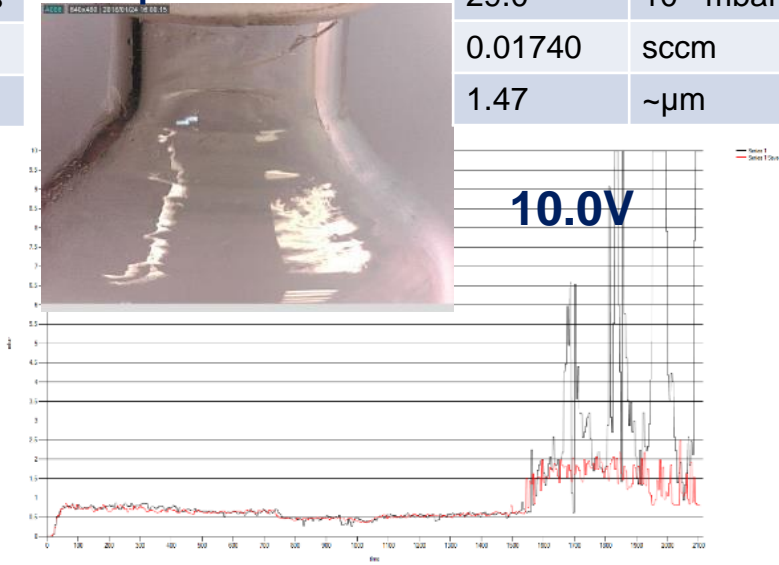
Sample 3

He Certified Leak Rate	
29.0	10^{-5} mbar·l/s
0.01740	sccm
1.47	$\sim\mu\text{m}$

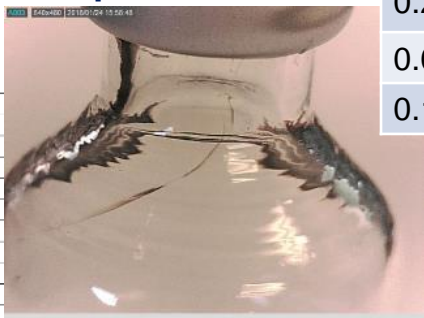
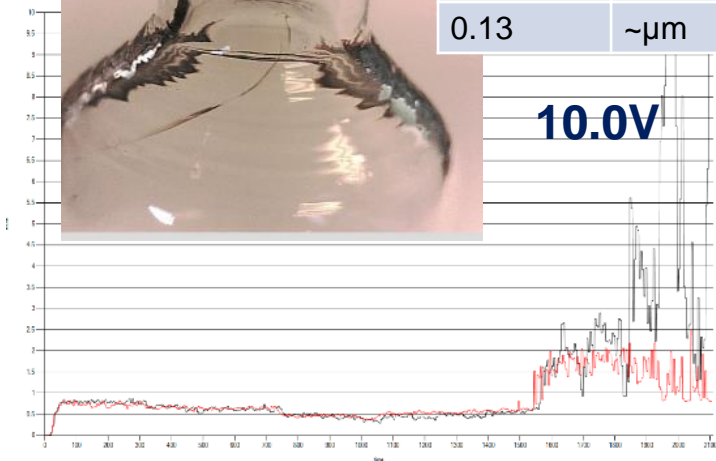
Sample 2

He Certified Leak Rate	
0.21	10 ⁻⁵ mbar-l/s
0.00013	sccm
0.13	~μm

10.0V

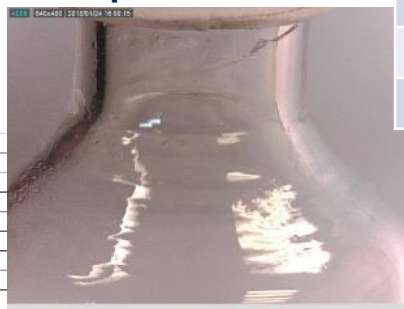
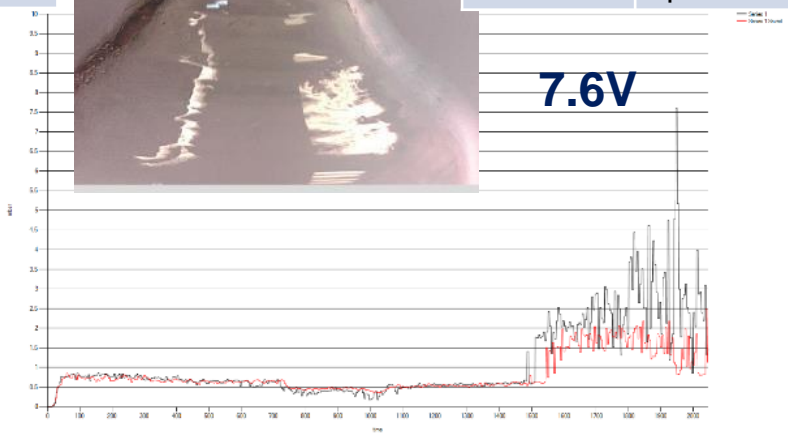
Sample 3

He Certified Leak Rate	
1.40	10 ⁻⁵ mbar-l/s
0.00084	sccm
0.32	~μm

7.6V

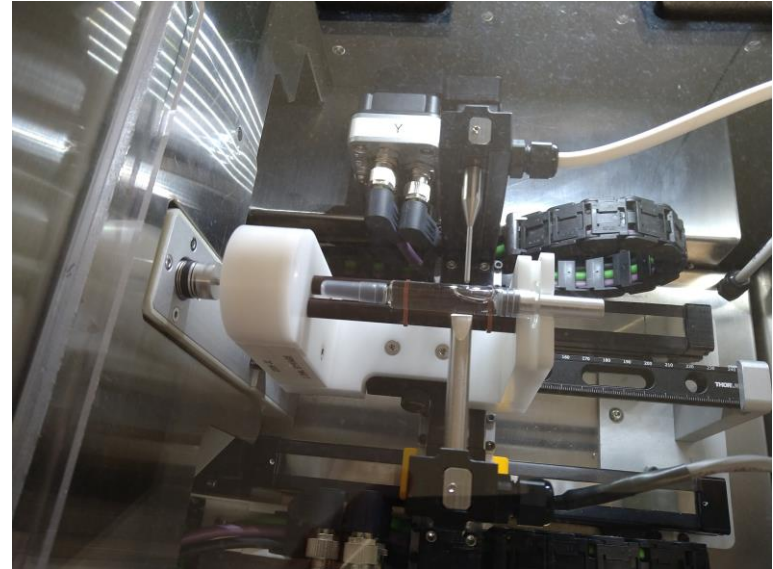
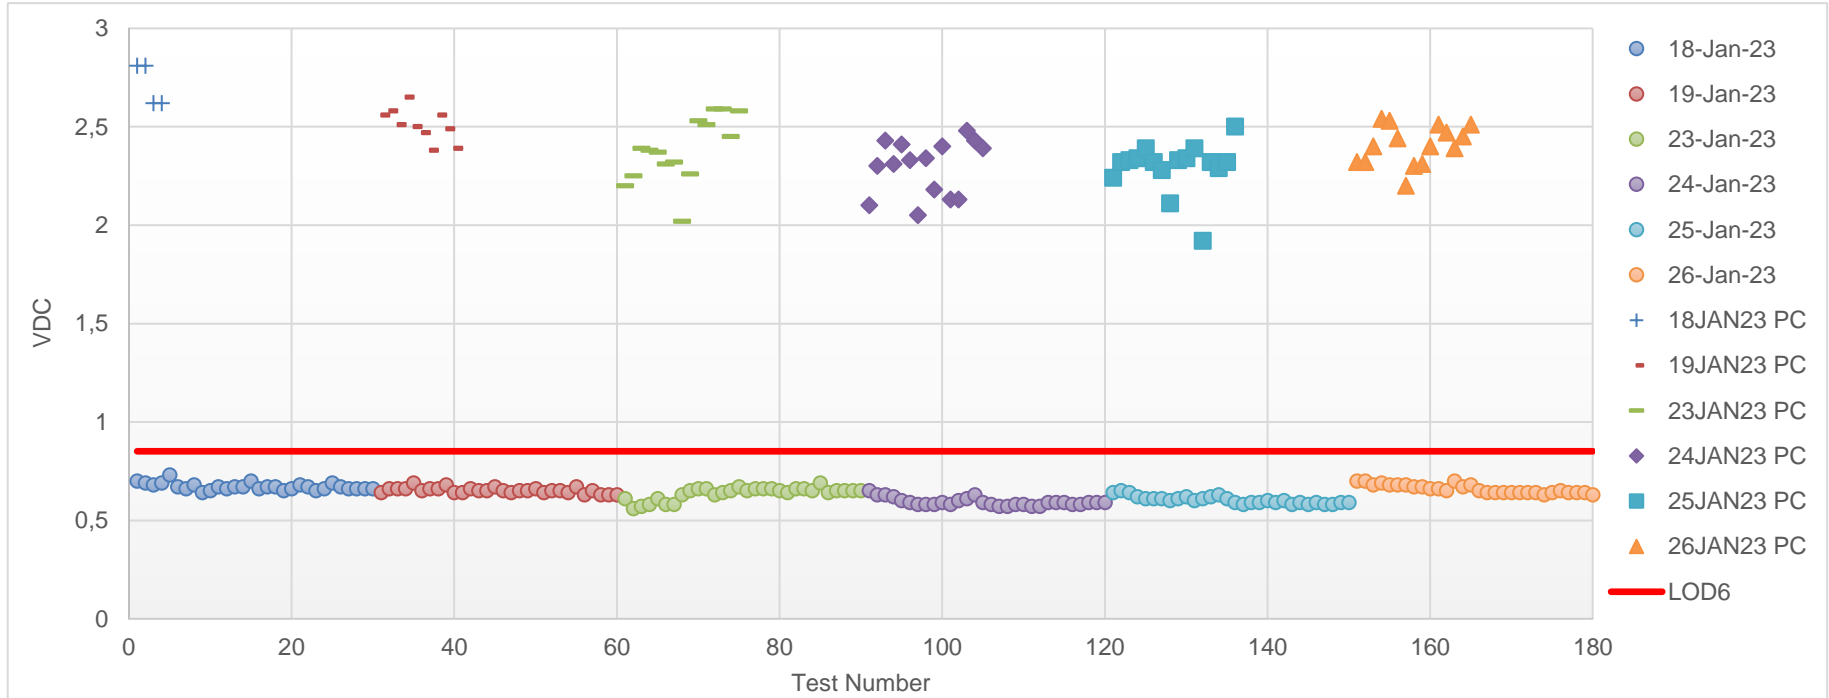
3mL cartridge (plunger defects)

Testing the plunger of a 3mL cartridge

- Defects done using capillaries (between the glass and the plunger) or laser drilled holes in the stopper
- Additional metallic pin touching the stopper
→ when electrode touches the metallic pin, defects can be detected
- Tests performed over multiple days (6 days)
